LEHIGH RIVER BASIN
POHOPOCO CREEK, PENNSYLVANIA

BELTZVILLE LAKE

CONDITION REPORT

DAM, OUTLET WORKS & SPILLWAY
PERIODIC INSPECTION REPORT NO.6

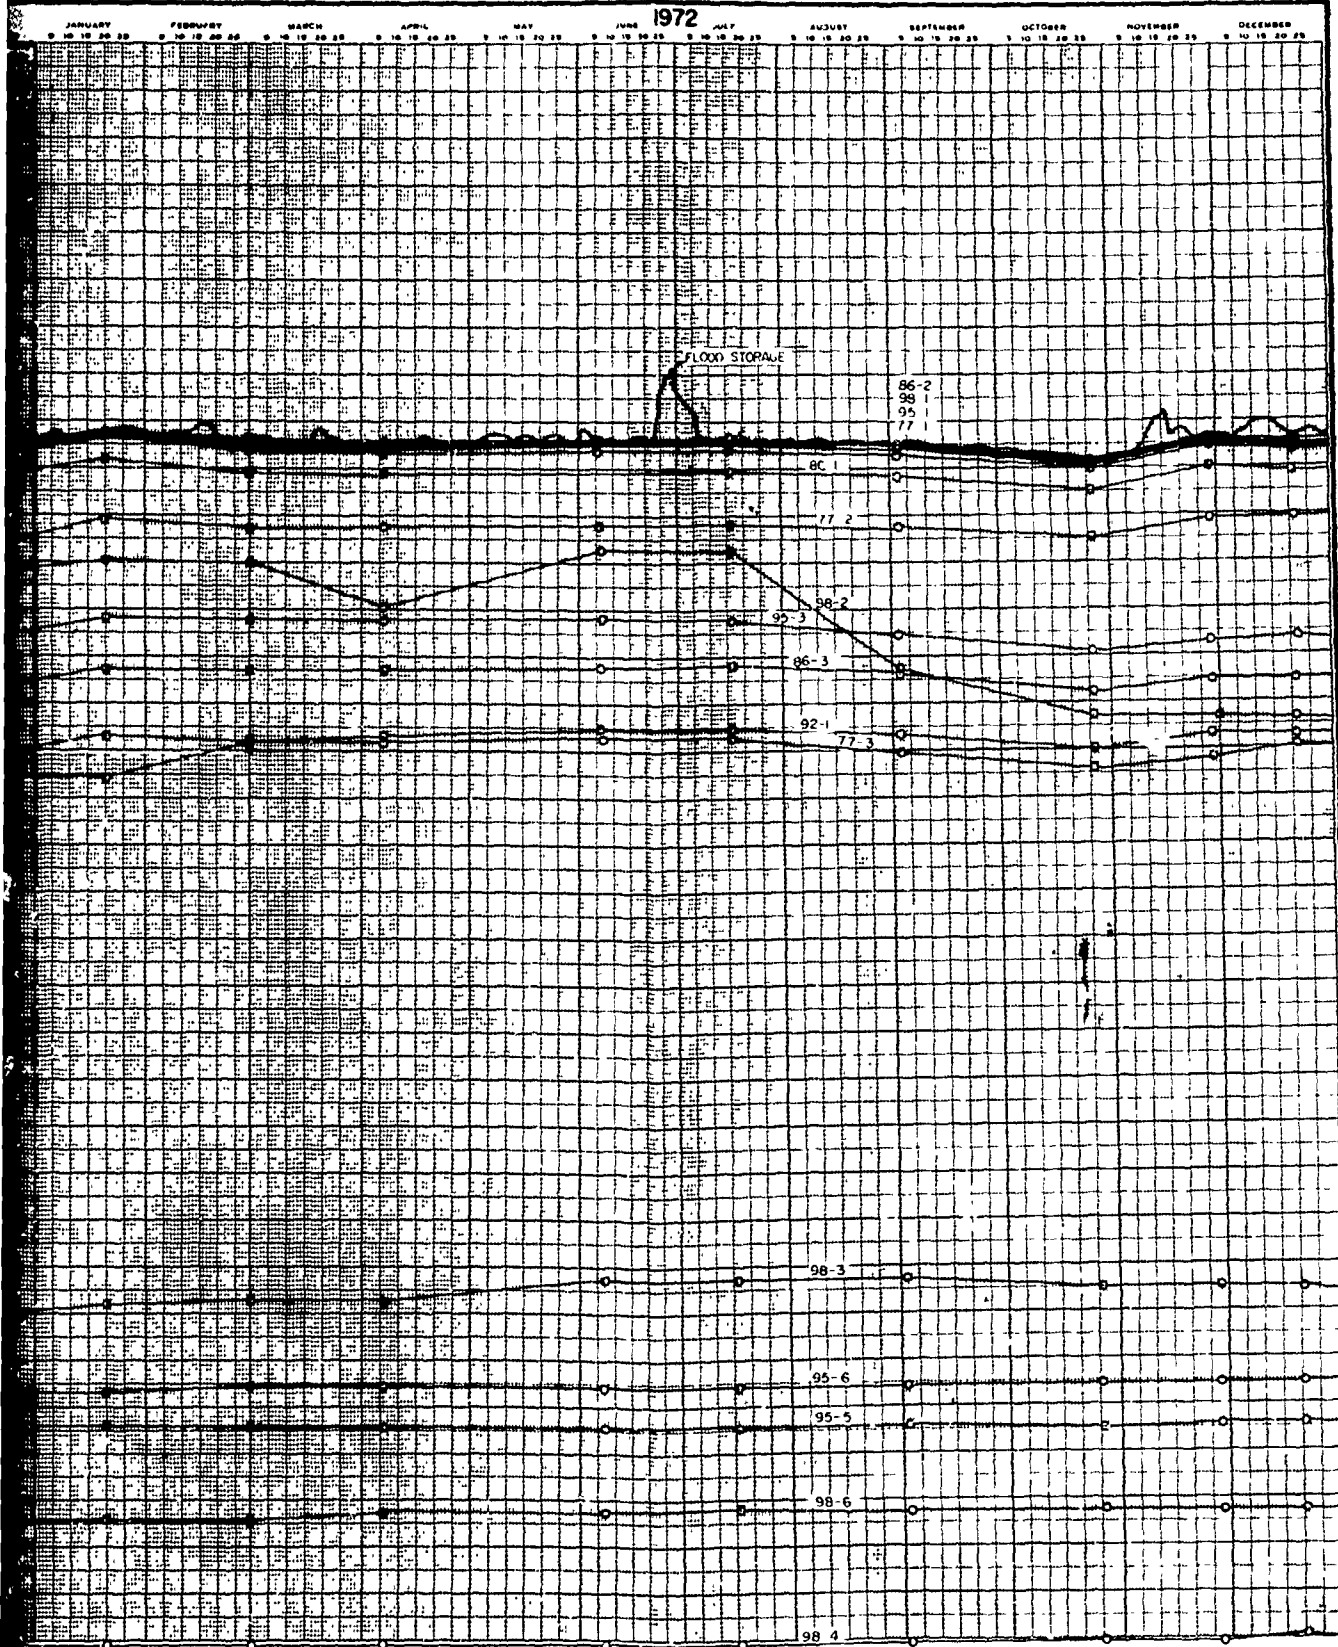
PIEZOMETER DATA
1971-1972

No. 95-4 became inoperative after 15 Dec. 1971

4-02 PIEZOMETERS. Upstream piezometers PZE-77-1, 86-2, 95-1 and 98-1 continued to respond to and hold within three feet of the reservoir operating level. One upstream piezometer, PZE 92-1, has continued to indicate piezometric levels substantially below operating pool levels. Impervious core piezometer PZC 77-2 continues to register a piezometric level at least 15 feet above that in other core instruments (PZC 86-3 and 95-3). This latter difference relates to core width at the various piezometers as noted in Periodic Report No. 2. Impervious core piezometer PZC-98-2 which experienced fluctuations and a relatively quick drop of 17 feet in 1972 has shown a slow decline of an additional 17 feet from that time to August 1976. All downstream pore pressure devices are of the pressure cell (Warlam) type. Their readings have generally become erratic and sporadic with increasing age or, in some cases, the installations have become totally inoperative. At present, only pressure cells PPF 86-5, PPF 98-3 and PPF 98-4 are operating satisfactorily. All remaining cells have either become inoperative (PPF 86-4, PPF 95-4, PPE 95-5, PPE 95-6 and PPE 98-6) or indicate unreliable readings (PPF 77-3 and PPE 98-7). PPF 86-5, located in the glacial outwash of the foundation, indicates a minimal head of two to three feet in that material at the downstream toe. PPF 98-3 and PPF 98-4 readings affirm the adequate functioning of the rockfill section as a drain. Piezometer records are shown on plates 1 through 4.

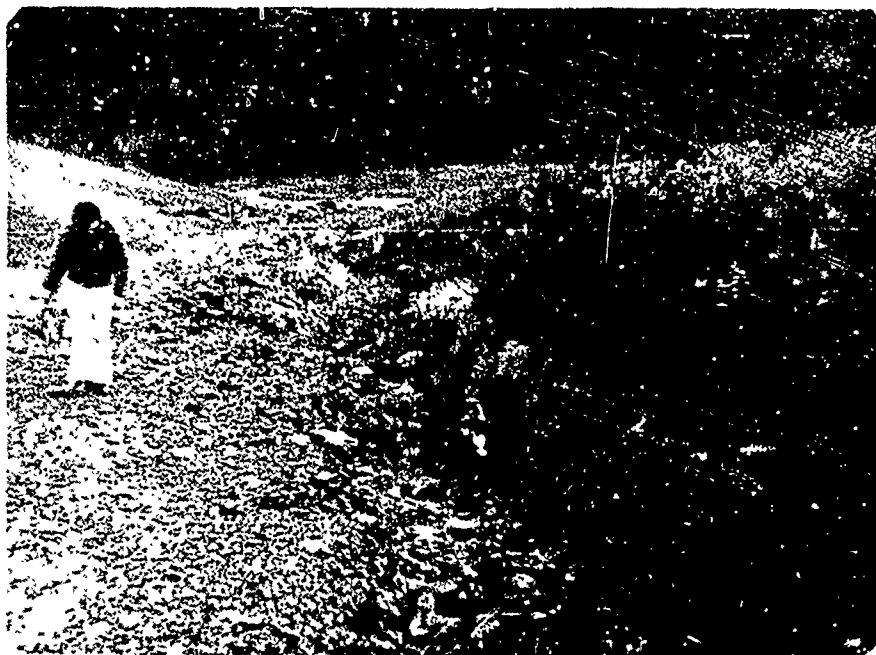
PHOTO 2 - Ditch looking towards stilling basin and large boulder pile shown in Photos 1 thru 1B (in left background). Note erosion - Nov 1976.

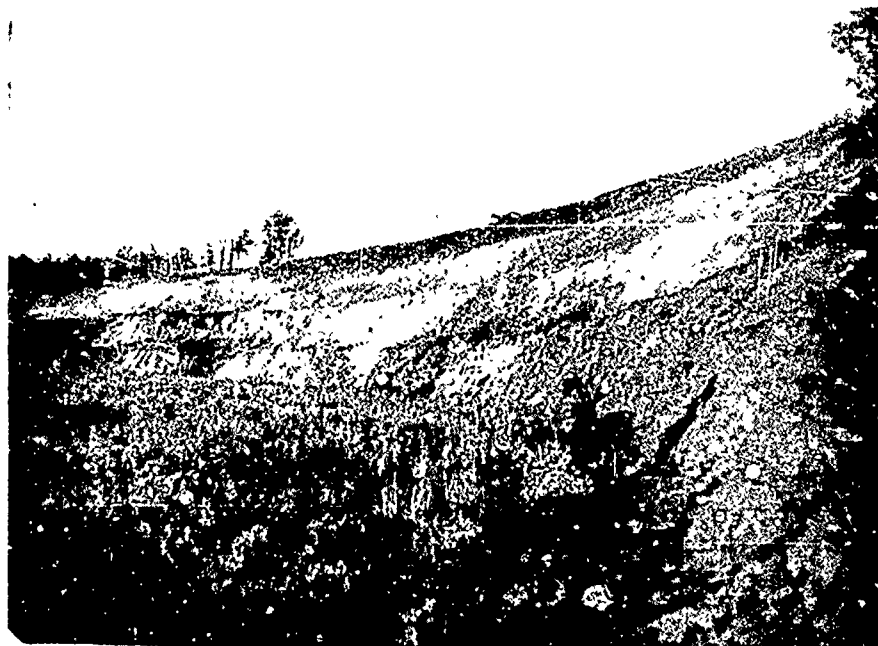
PHOTO 4 - Rock falls along right slope of spillway, upstream of spillway bridge - Nov 1976.

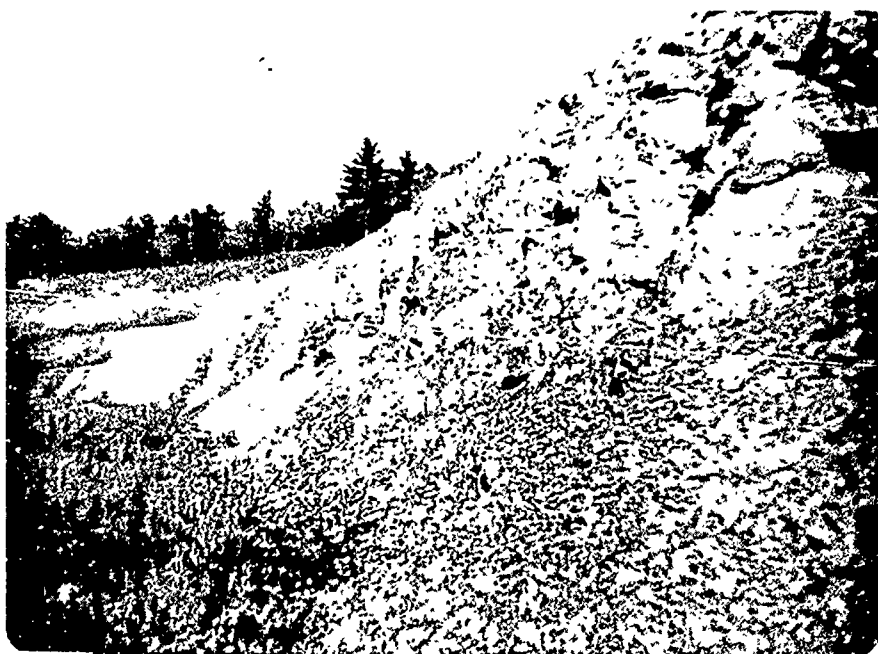
PHOTO 5 - Same as photo 4 from point further downstream - Nov 1976.

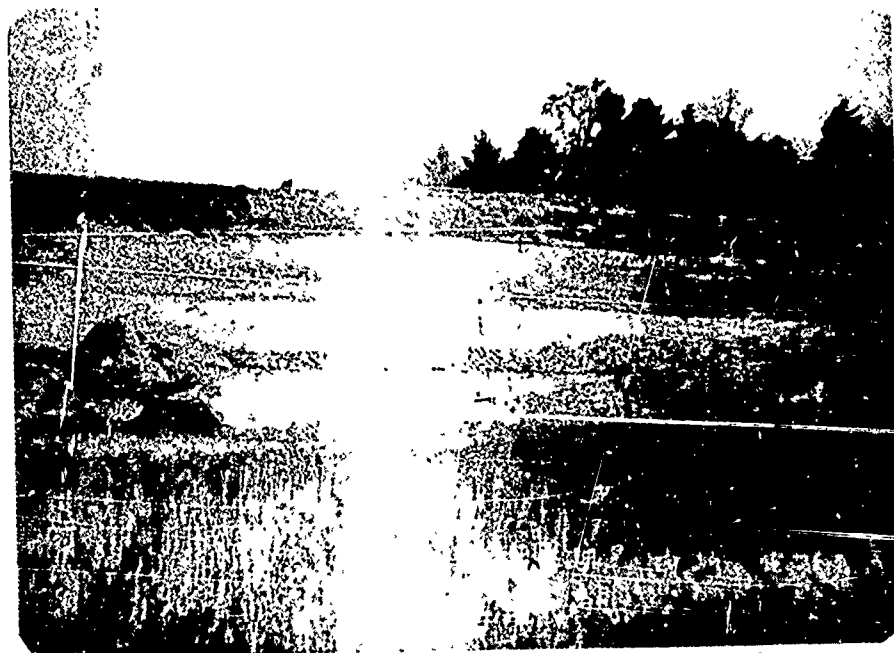
PHOTO 6 - ... ls in right slope of
spillway - ...
